RASSAR:

Room Accessibility and Safety Scan in Augmented Reality

Xia Su, PhD Student, UW CSE

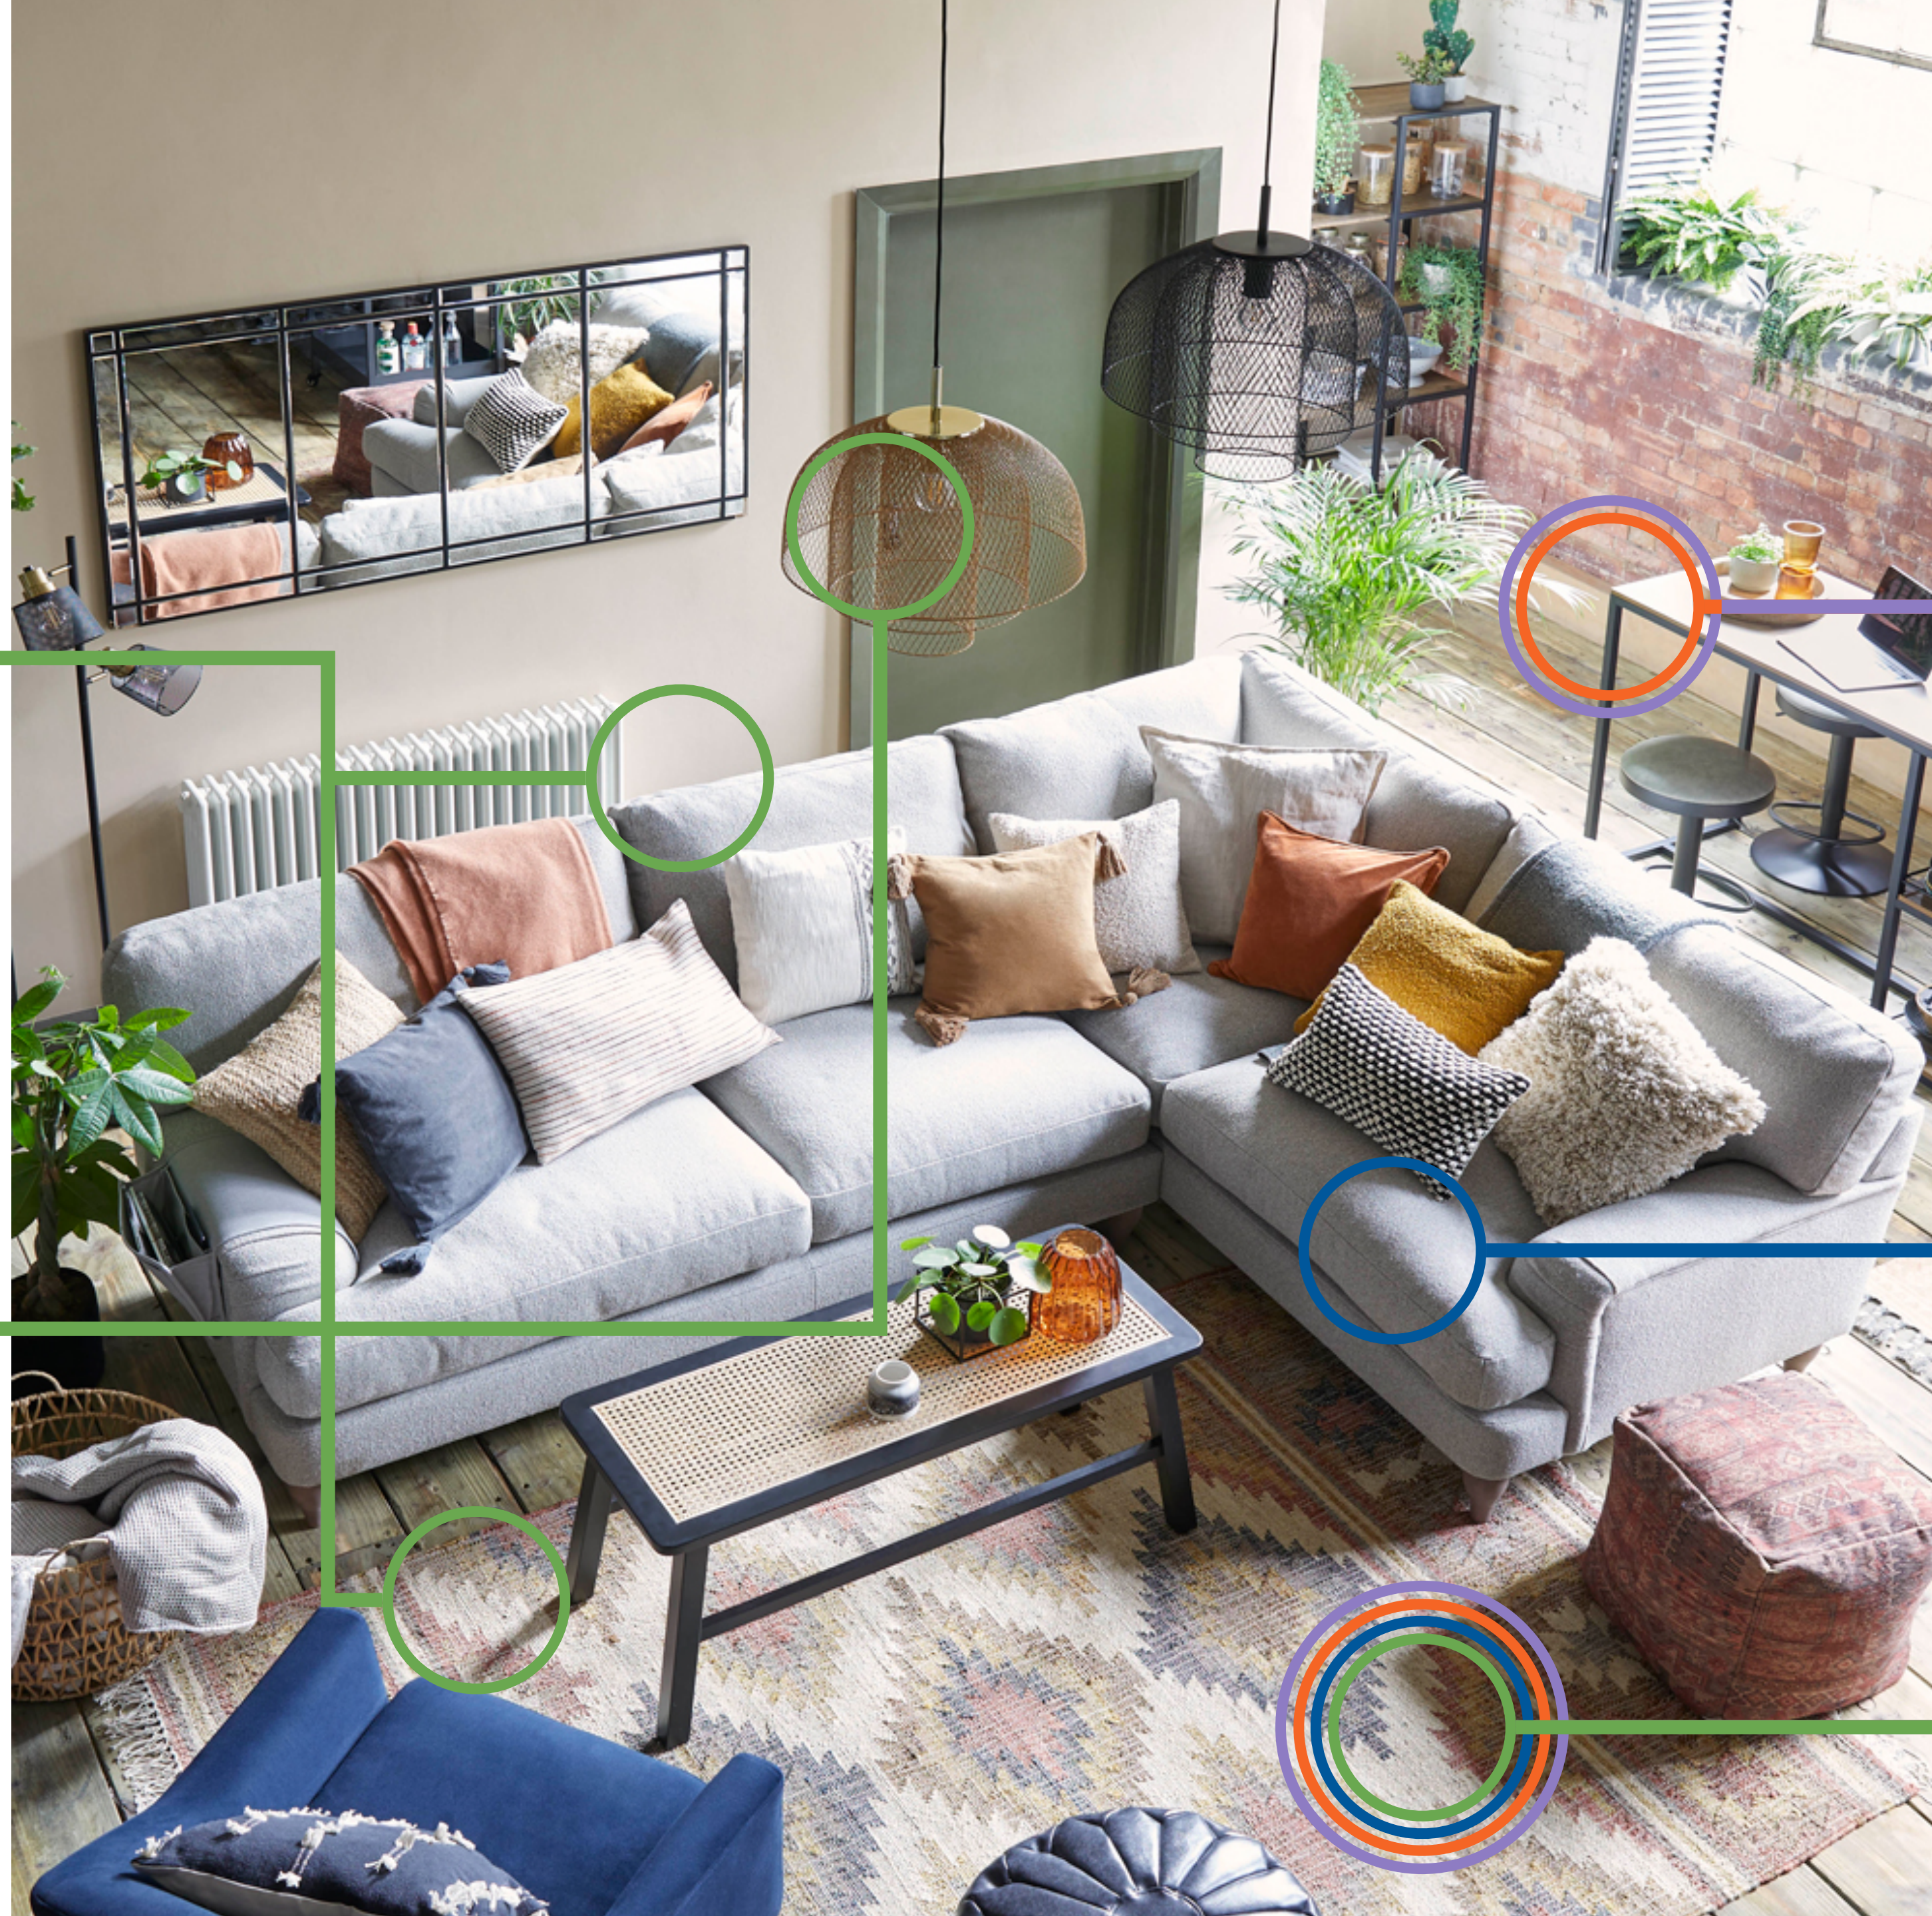
Unreachable
Space

Inaccessible
Knob

Sharp Edges

Low Sofa

Throw Rug

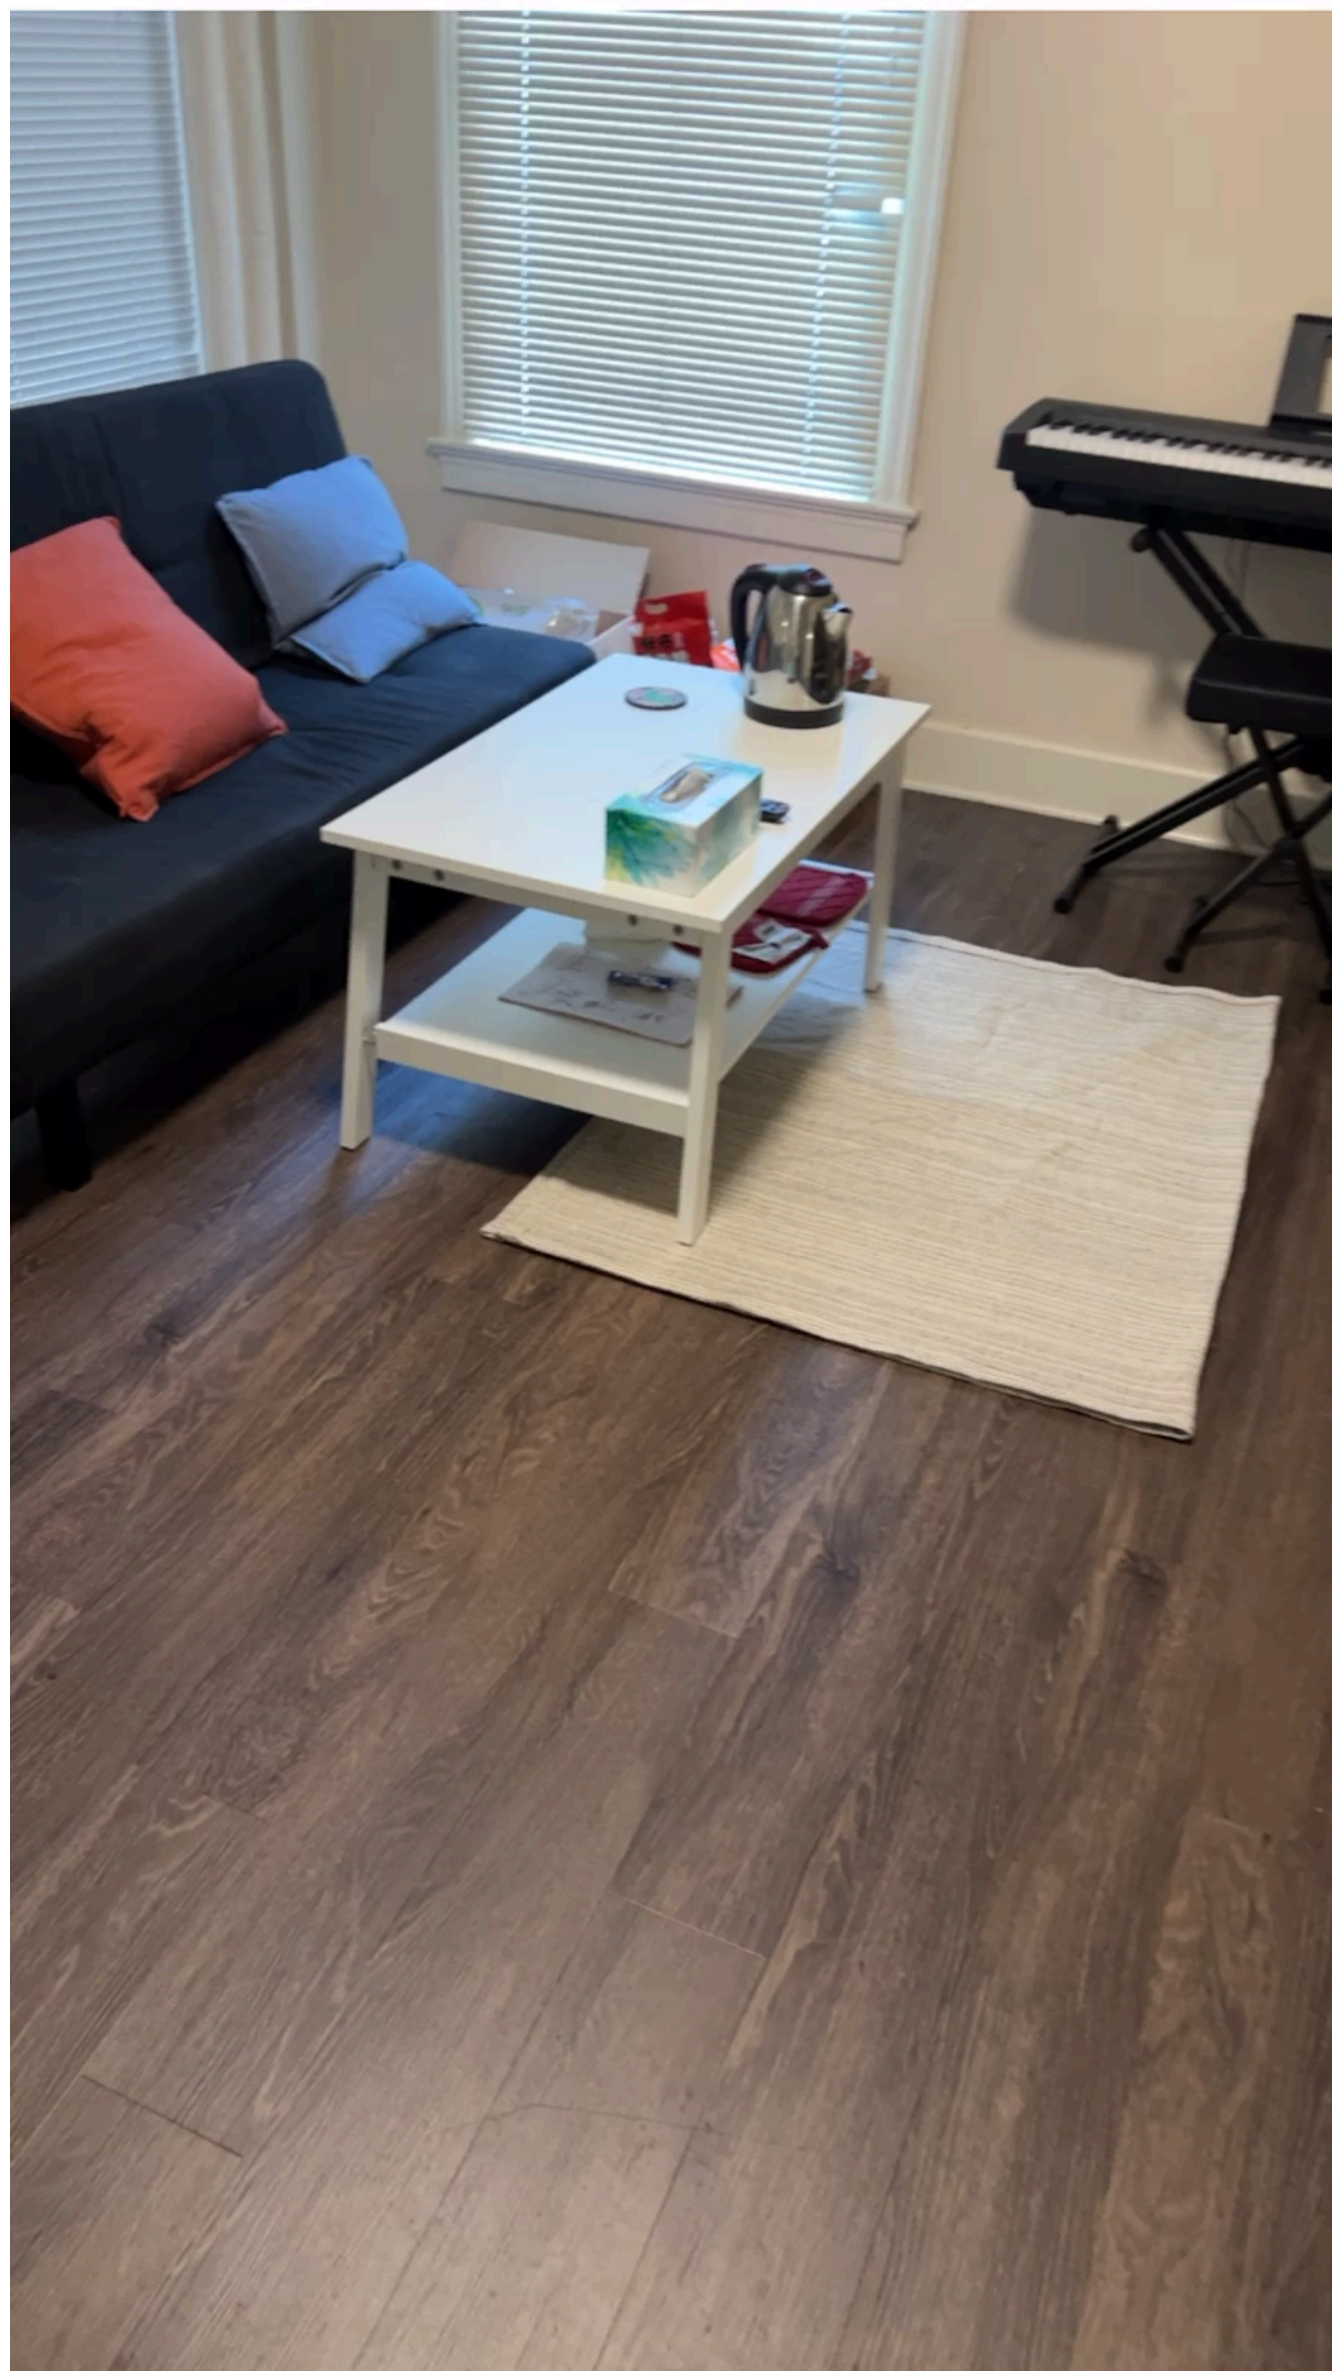
LiDAR

Sofa
1.8m*0.8m*0.6m
(X,Y,Z)

Table
1.1m*0.4m*0.6m
(X,Y,Z)

Storage
1.7m*0.5m*0.3m
(X,Y,Z)

Rug
(X,Y,Z)

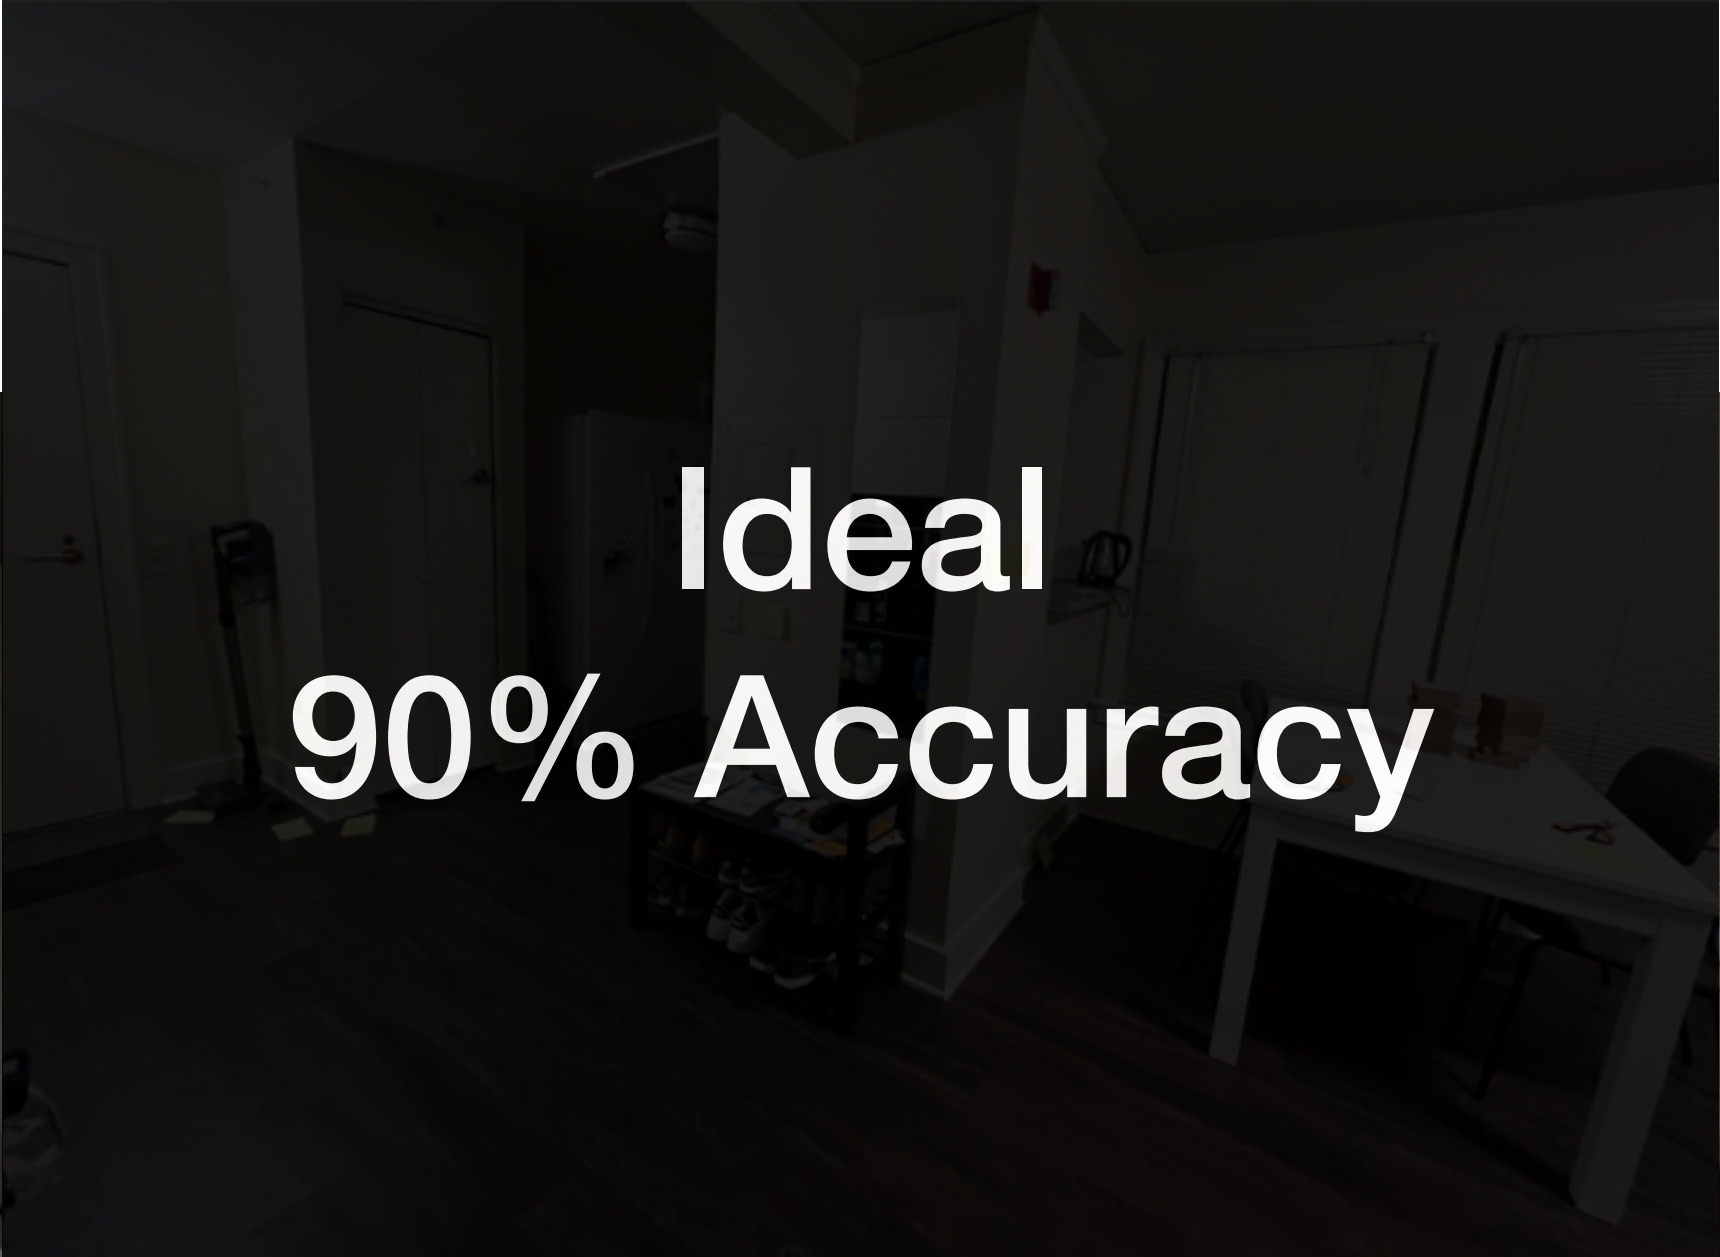
Poorly Lit
48% Accuracy

Ideal
90% Accuracy

Messy
72% Accuracy

Well-lit
Tidy

Scan with medium speed (1min/room)

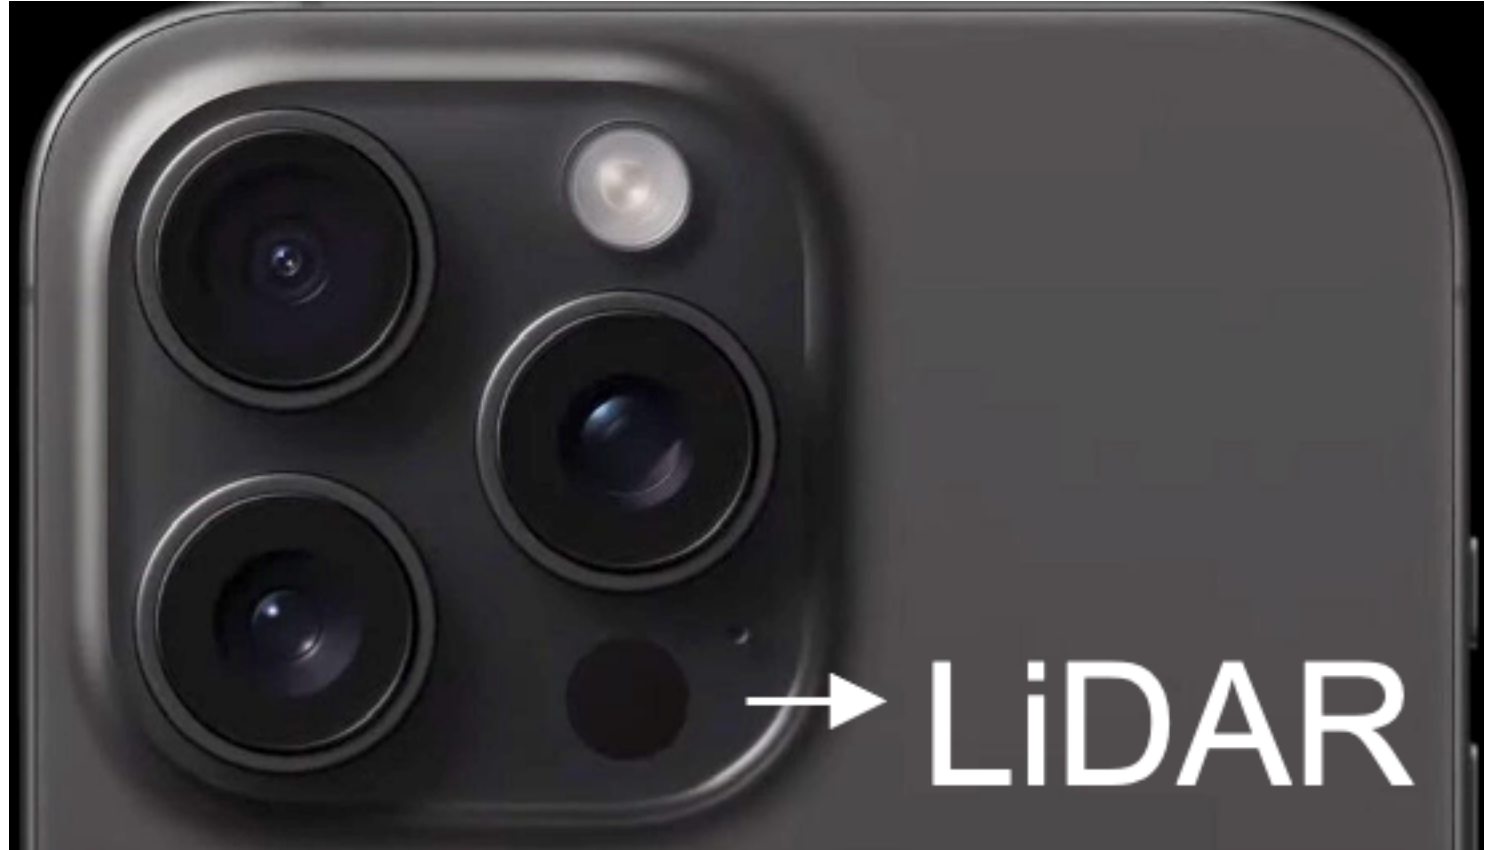
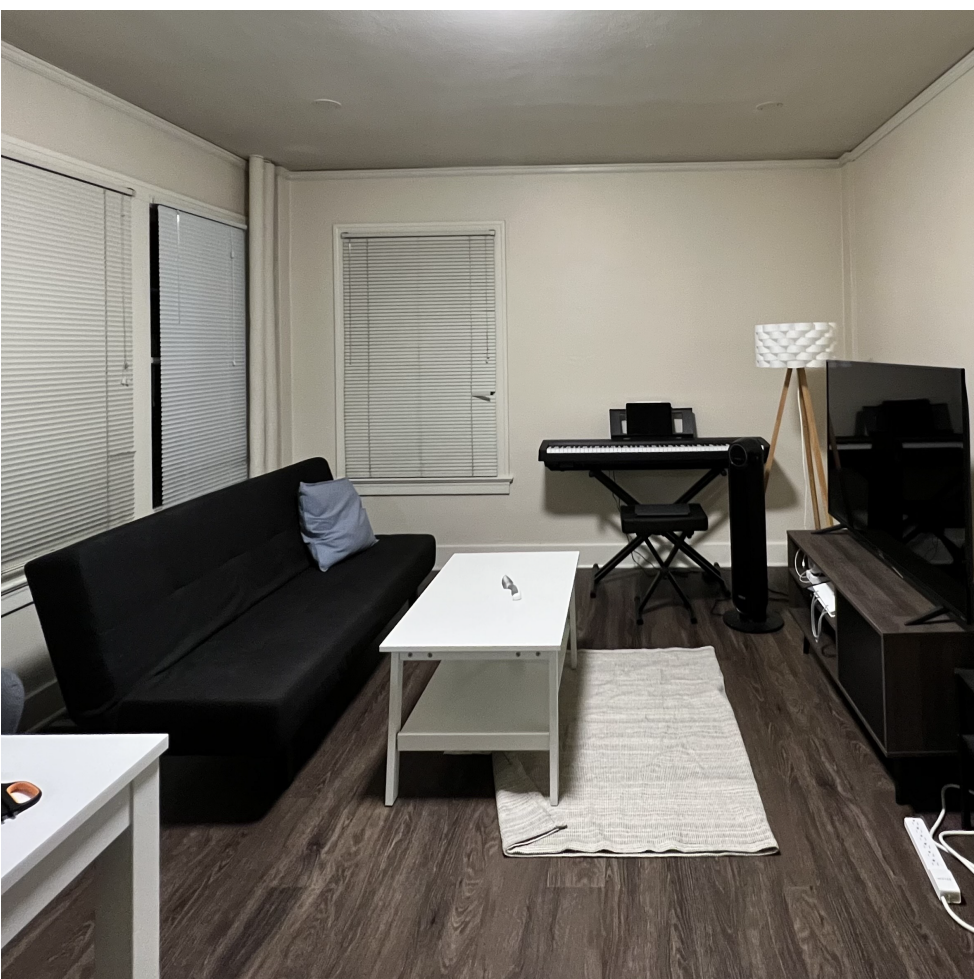
Pipeline

↑
LiDAR &
RGB Camera

RoomPlan
YoloV5

Rubrics in
JSON

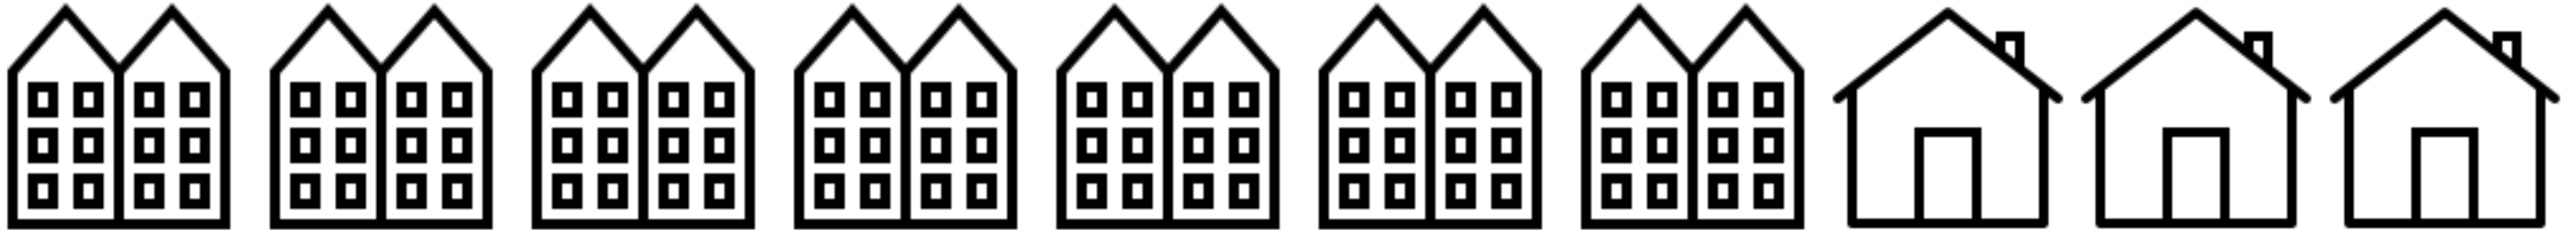
Technical Eval

7 Apartments

3 Houses

Manual Inspection
Scan 3 times
Compare Results

Accuracy
Consistency
Time
