A Feasibility Study of Crowdsourcing and Google Street View to Determine Sidewalk Accessibility

Kotaro Hara, Victoria Le, and Jon Froehlich
Human-Computer Interaction Lab
Computer Science Department, University of Maryland
College Park, MD 20742
{kotaro, jonf}@cs.umd.edu; vnle@umd.edu

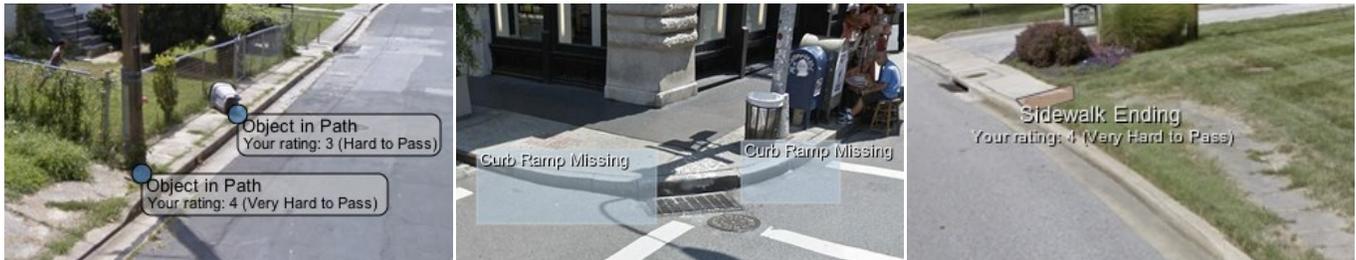
Figure 1. Using crowdsourcing and Google Street View images, we examined the efficacy of three different labeling interfaces on task performance to locate and assess sidewalk accessibility problems: (a) *Point*, (b) *Rectangle*, and (c) *Outline*. Actual labels from our study shown.

To collect geo-labeled data on sidewalk accessibility problems in GSV images, we created an interactive online labeling tool in Javascript, PHP and MySQL, which works across browsers. Labeling GSV images is a three step process consisting of *marking* the location of the sidewalk problem, *categorizing* the problem into one of five types, and *assessing* the problem's severity. For the first step, we created three different marking interfaces: (i) *Point*: a point-and-click interface; (ii) *Rectangle*: a click-and-drag interface; and (iii) *Outline*: a path-drawing interface. We expected that the *Point* interface would be the quickest labeling technique but that the *Outline* interface would provide the finest pixel granularity of marking data (and thereby serve, for example, as better training data for a future semi-automatic labeling tool using computer vision).

Once a problem has been marked, a pop-up menu appears with four specific problem categories: *Curb Ramp Missing*, *Object in Path*, *Prematurely Ending Sidewalk*, and *Surface Problem*. We also included a fifth label for *Other*. These categories are based on sidewalk design guidelines from the US Department of Transportation website [3] and the US Access Board [2]. Finally, after a category has been selected, a five-point Likert scale appears asking the user to rate the severity of the problem where 5 is most severe indicating "not passable" and a 1 is least severe indicating "passable." If more than one problem exists in the image, this process is repeated. After all identified sidewalk problems have been labeled, the user can select "submit labels" and another image is loaded. Images with no apparent sidewalk problem can be marked as such by clicking on a button labeled "There are no accessibility problems in this image." Users can also choose to skip an image and record their reason (e.g., image too blurry, sidewalk not visible).

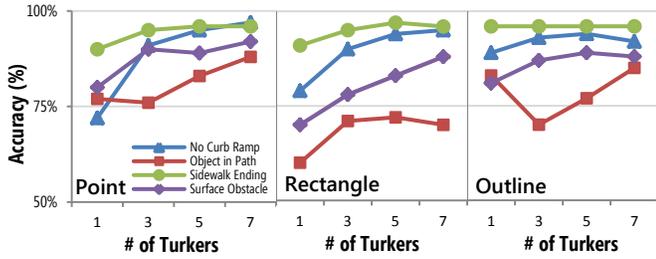
Figure 2. The number of turkers per image vs. accuracy for each of the three labeling interfaces. Note that the y-axis begins at 50%.

We also explored accuracy as a function of the number of turkers per image and as a function of label type. To do this, we calculated four different turker-based majority vote datasets for each interface based on four different turker group sizes: 1, 3, 5, and 7. Group membership was determined based on the order of completion for each hit. The results are shown in Figure 2. Note that, again, we perform these comparisons at the *image* level rather than the individual label level and that we again ignore severity. These calculations are left for future work.
